**INVESTIGATION INTO THE CRASH OF
DASSAULT FALCON 50
REGISTRATION NUMBER 9XR-NN
ON 6 APRIL 1994 CARRYING FORMER
PRESIDENT JUVENAL HABYARIMANA**

CONTRACT REPORT

Part of Defence Academy of the UK
Report Number DASSR/MW/1434/09
27 February 2009
Report for CEIFALC 50

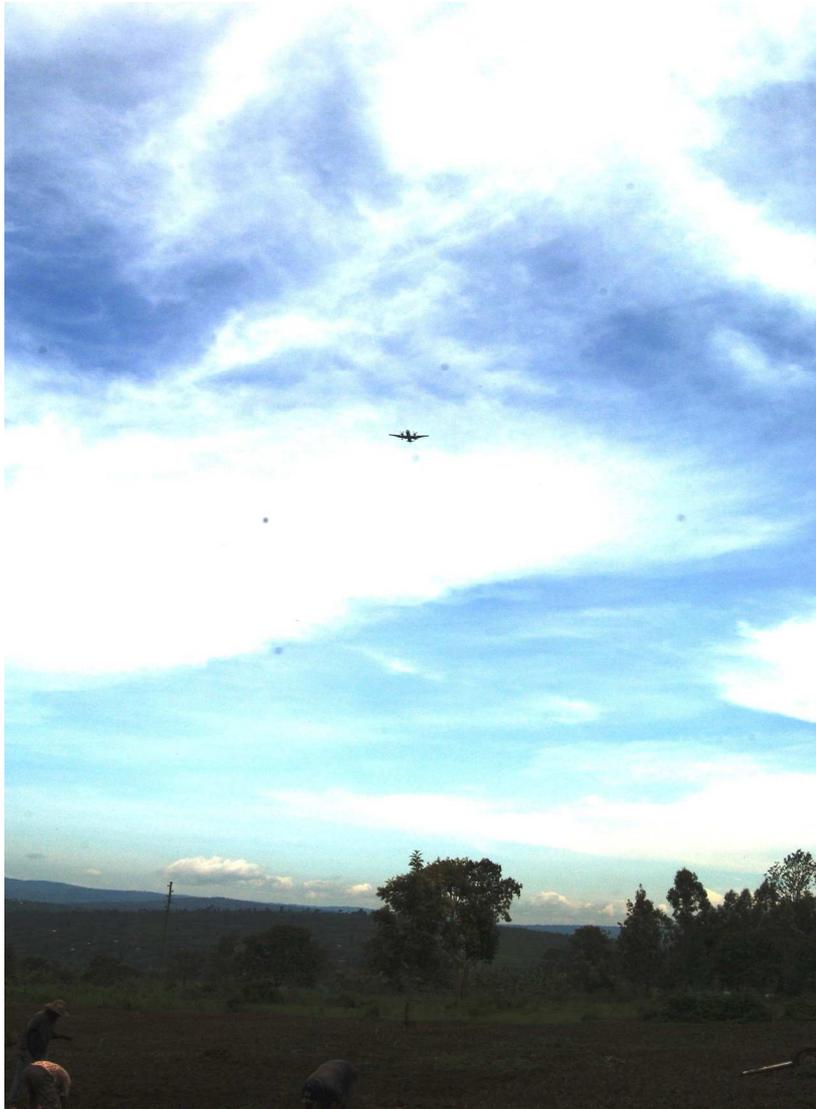
Fig. 16: View of Approaching Aircraft on Flight Path Taken from Crash Site

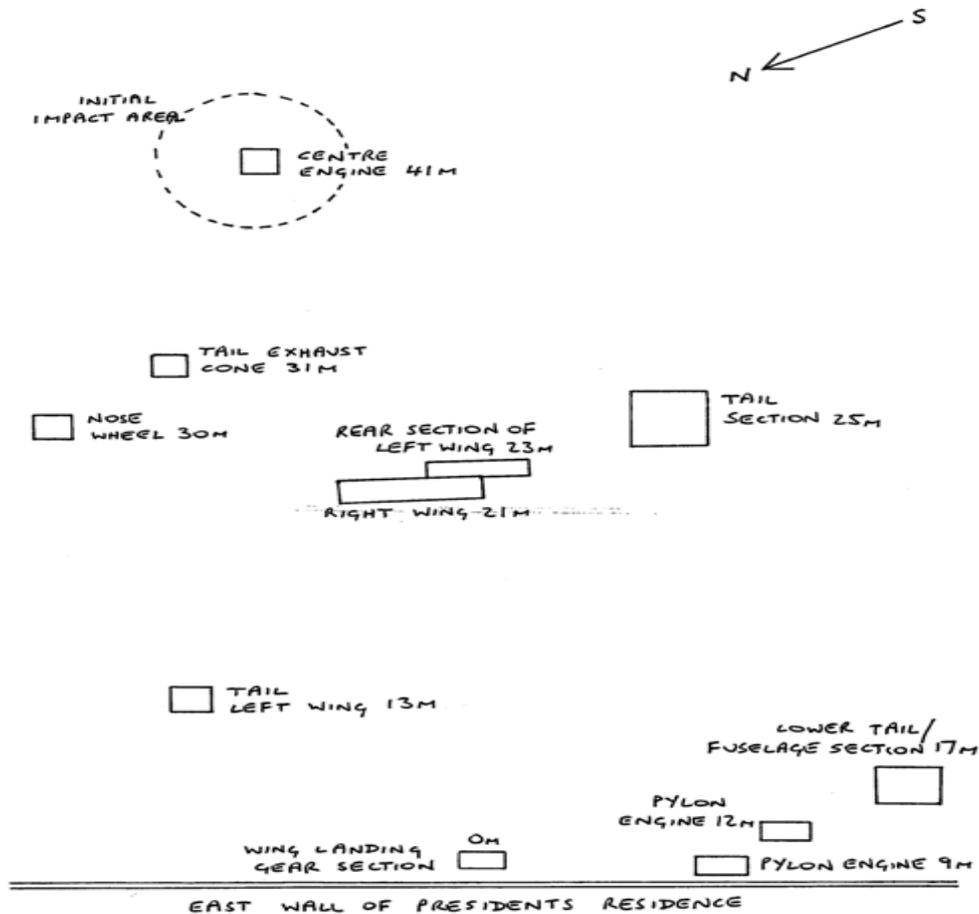
SKETCH MAP OF CRASH SITE 2009

NOT TO SCALE : ALL DISTANCES ARE IN METRES FROM THE WING LANDING GEAR SECTION

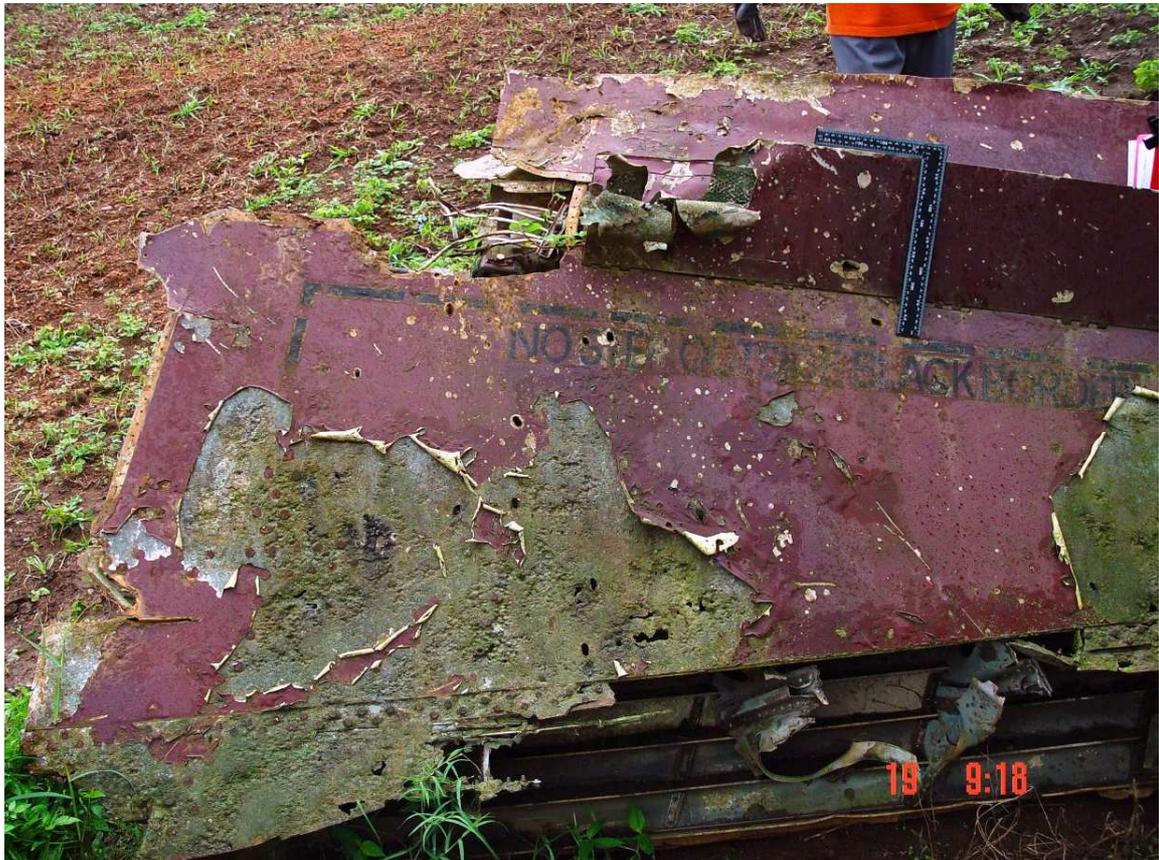
Fig. 22: Rear Section of Left Wing (1).

Detailed photographs of possible forensic evidence are shown in Annex L. A portion of the rear section of the left wing exhibited possible fragmentation damage including an area believed to have been exposed to fire damage and subsequent corrosion. Unfortunately the fragments had either fully penetrated through both outer skins of the wing or where they had only penetrated a single skin these had been lost to ground through the nature of the wing construction and the forward section being open to ground. No residual fragmentation was found and no ground search was carried out.

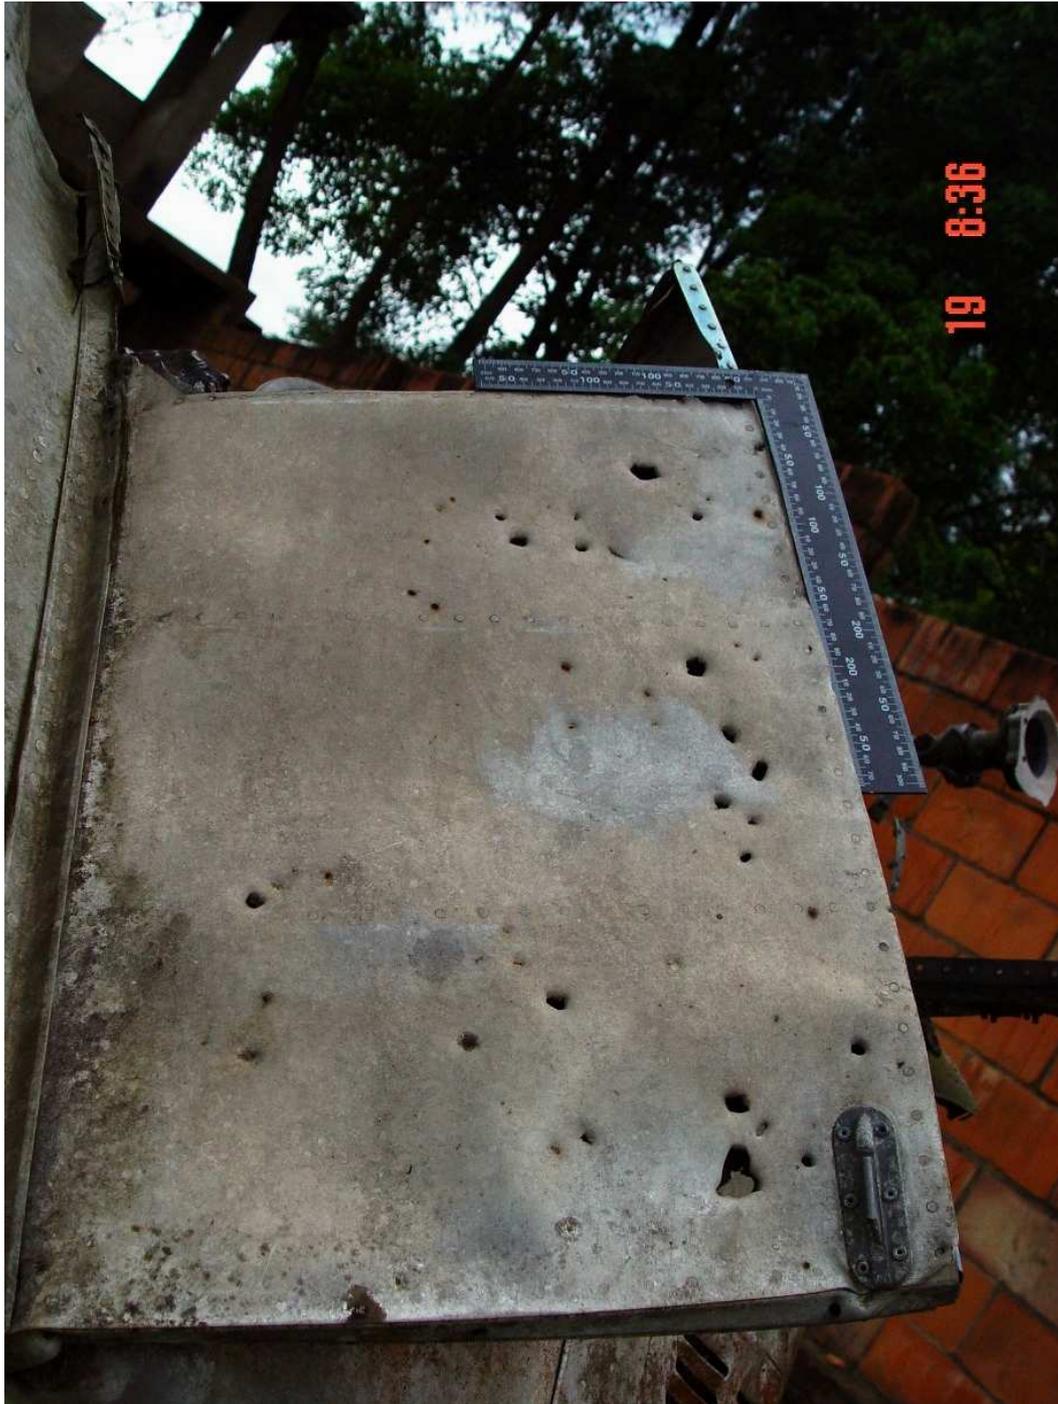
Fig. 29: Box panel (1).

A box panel on the lower tail/fuselage section exhibited some possible fragmentation damage and some surface fragmentation capture. The box panel was compartmentalised into three sections separated by internal support struts to which the outer skins of the aircraft were riveted. By careful cutting to open the upper section and by popping the rivets each compartment

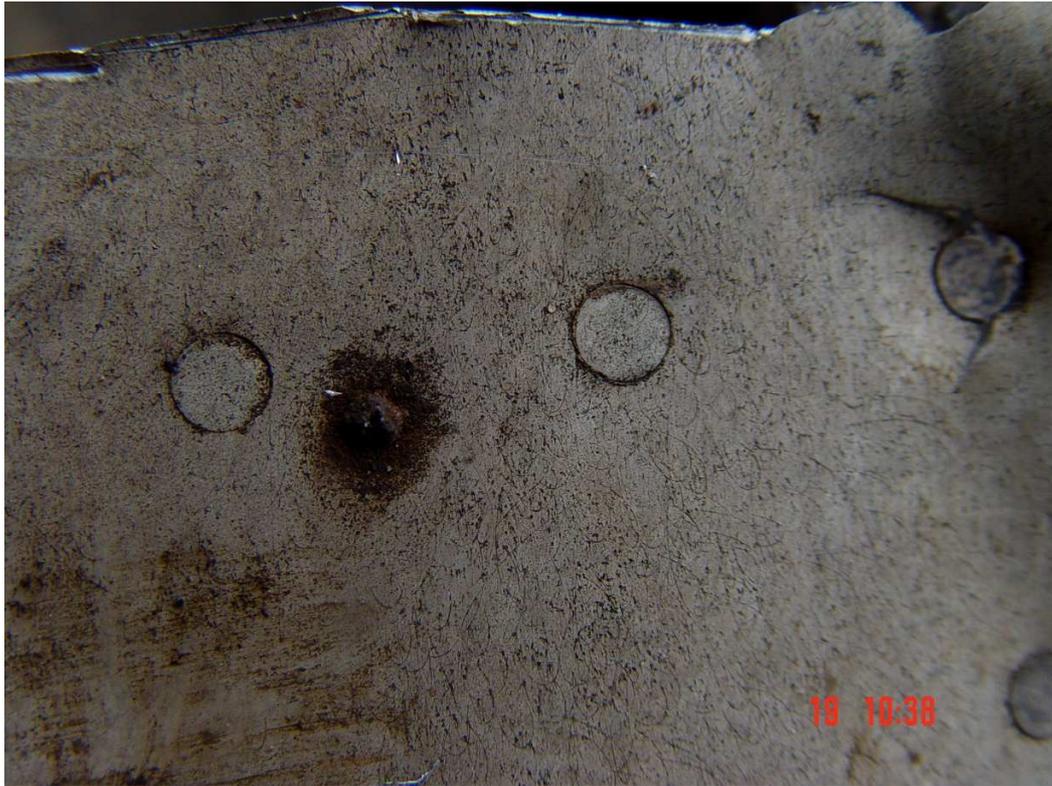
Fig. 34: Box Panel Fragment Capture (1)

After fifteen years the majority of the contents of each compartment comprised possible organic matter. The matter was carefully sifted to expose any metallic material that may have been the cause of the fragmentation present on the box panel outer skin. A small quantity of possible metallic residue was collected for analysis by Cranfield University on the authors return to the UK. A section of the box panel outer skin approximately 210mm x 150mm exhibiting some surface fragmentation capture was removed by the authors for subsequent analysis in the UK. The embedded material exhibited possible oxidization characteristics indicating unlike materials to the outer skin of the box panel. The results of the analyse carried out are included at Annex P and commented upon in Section 8 – Conclusions.
